Control Upgrade of 1200 Ton Cold Chamber Die Casting Machine

Arick Kaschalk
Visi-Trak Worldwide
Valley View, Ohio

Jeff Nutter
MPG (formerly Metaldyne)
Twinsburg, Ohio

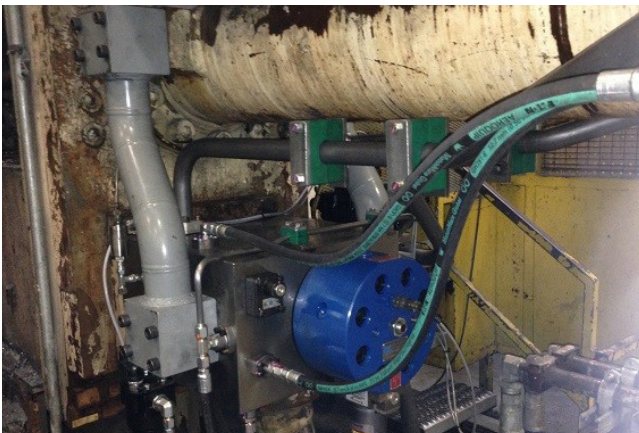
Figure 1 - Operator Side View of Meter-Out Hydraulic Circuit Upgrade.

After reviewing these objectives, Visi-Trak recommended an upgrade package that included the Sure-Trak2™ Shot Control System, 80mm Olmsted SV Cartridge Valve piloted with a Woodward HRT R-DDV Servo Valve®, a Conversion Manifold, Total-Trak2™ HMI, Visi-Trak® 20-Pitch Tail Rod and Transducer Assembly and an option for proportional control of Intensification Pressure.

The most vital component of the project was the Olmsted SV Cartridge Valve, which is specifically engineered for the rigorous die cast injection process. The aforementioned slow/intermediate and fast phases of injection, along with low impact, are all accomplished with use of this valve, which has a lightweight gate assembly and a unique flow window to accommodate rapid acceleration as well as controlled deceleration. Two critical feedback loops are provided to enable true closed loop control of the shot cylinder. A Linear Variable Differential Transformer (LVDT) provides throttling valve position feedback. The shot stroke sensor provides the critical outer feedback loop to insure the speed programmed follows the velocity commanded through the motion controller.

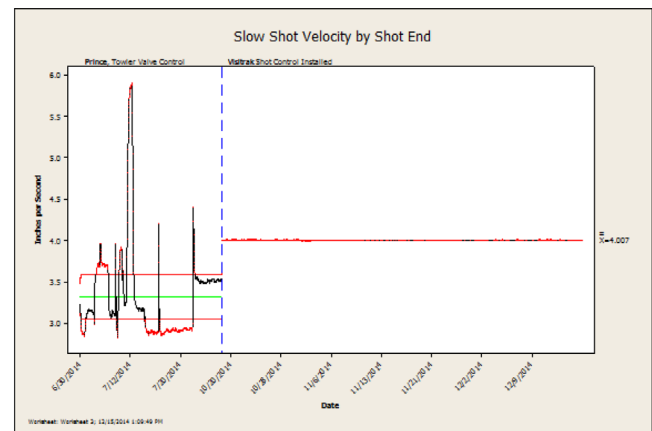
Figure 2 - Slow Shot Velocity - Disturbances in this velocity can contribute to trapped gas porosity.

First, the trend chart for the four parameters comprising the objectives of the project was reviewed. Below are the results with the vertical blue dashed line demarcating when the upgrade took place. A marked improvement for slow, intermediate, and fast shot velocities was observed. As well as showing an improvement, end of shot position became more reliable and adjustable. Calculated start of fast shot showed moderate improvement.

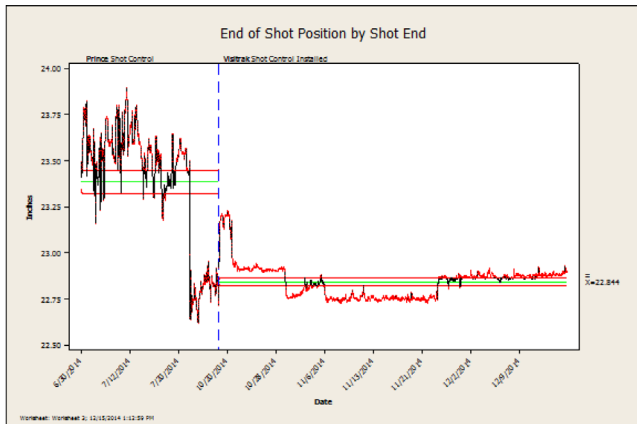
End of shot position was predominantly challenging, resulting in many occurrences of flashing the die. When the die is almost completely full, there is much inertia with the hydraulic cylinder’s forward momentum. Without a robust Low Impact system offering the capability of controlling this momentum, the clamp end can become overwhelmed and the result will be aluminum on the die surface. Excess aluminum on the die surface needs to be cleaned off the surface of the die prior to commencing operation, otherwise the die lifetime becomes compromised. The issues related to excess aluminum on the die accounted for a large portion of downtime on this machine.

Figure 6 – End of Shot Position – Variance will result in flashing the die, scrapped parts & significant machine down time.

The data showed significant improvement in the parameters most critical to the project. Die flashing occurrences were drastically reduced, resulting in almost complete elimination of the problem.

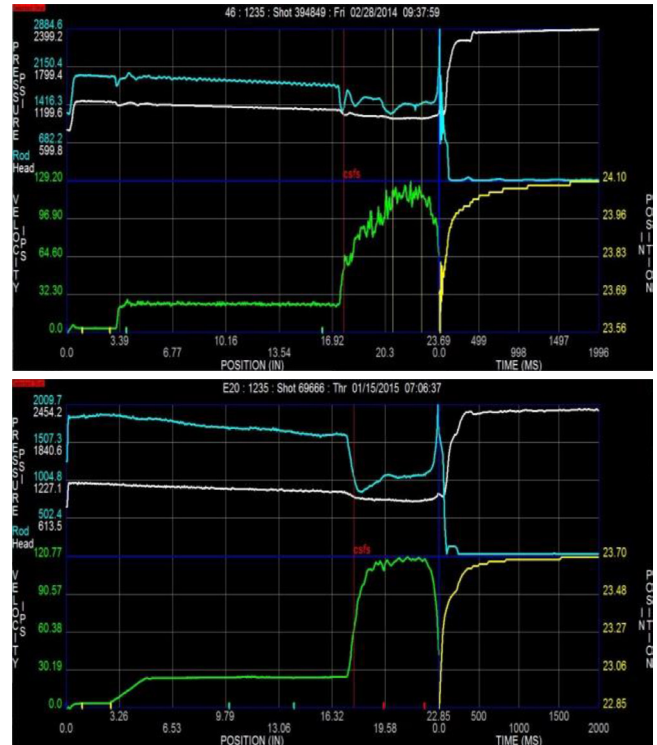
Figure 7 – Before and After Shot Traces displaying improved injection performance with ramping capability in slow/intermediate phase and decreased Fast Shot Rise Time.

machine. The higher response of the valve/control system has minimized spikes in the hydraulic system and moved these downtime reasons to 10th or higher place.

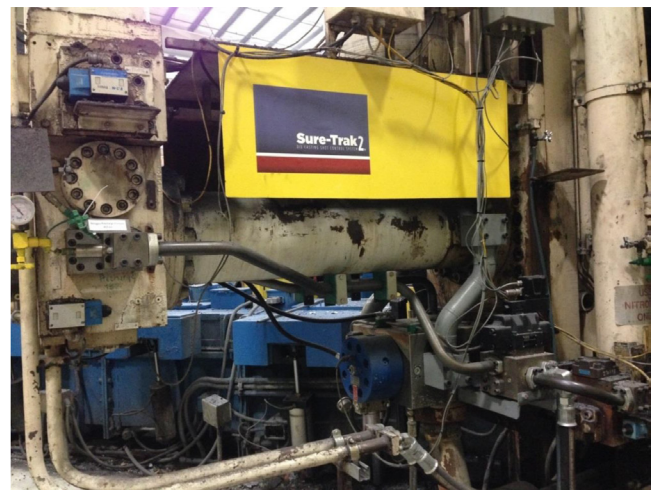
Figure 8 – View from the Helper side – 1 year of operation with no components replaced and no downtimes for Hydraulic Leaks on the Shot End.

After installation, two unanticipated results were found after one year of machine operation: there were no downtime instances for hydraulic leaks on the shot end and there were no spare part replacements after one year of operation. Previously, shot end hydraulic leaks and shot end repair were in the top 5 reasons for downtime on this
