# Visi-Trak<sup>®</sup>

**AHRESTY, WILMINGTON**

CASE STUDY

# THE TORO COMPANY

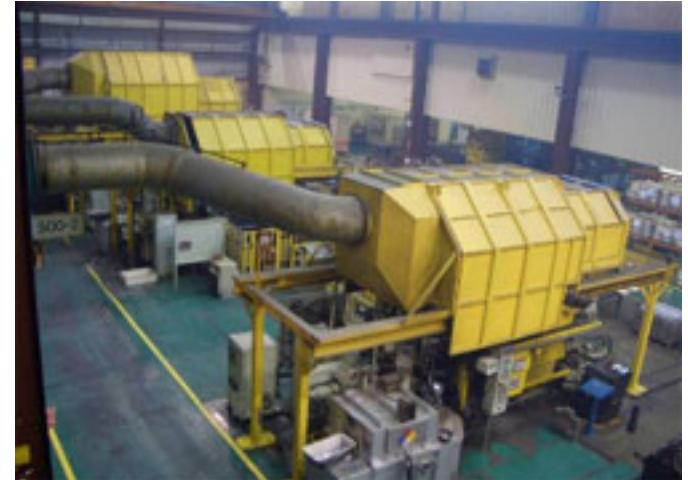
### ■ 24 die casting machines

- 3 Prince (500-1650 ton)
- 2 Toshiba (2250 ton)
- 19 Ube (500-2250 ton)

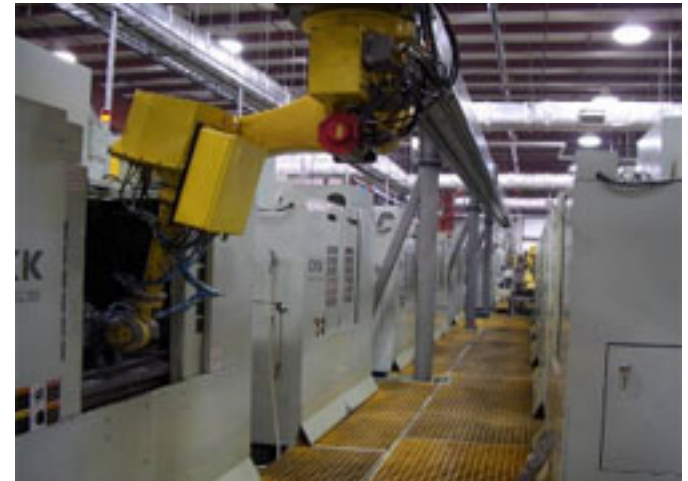
### ■ Machining

- Manual load and fully automated machining lines
- Leak test for all lines
- Vision systems for quality confirmation checks.

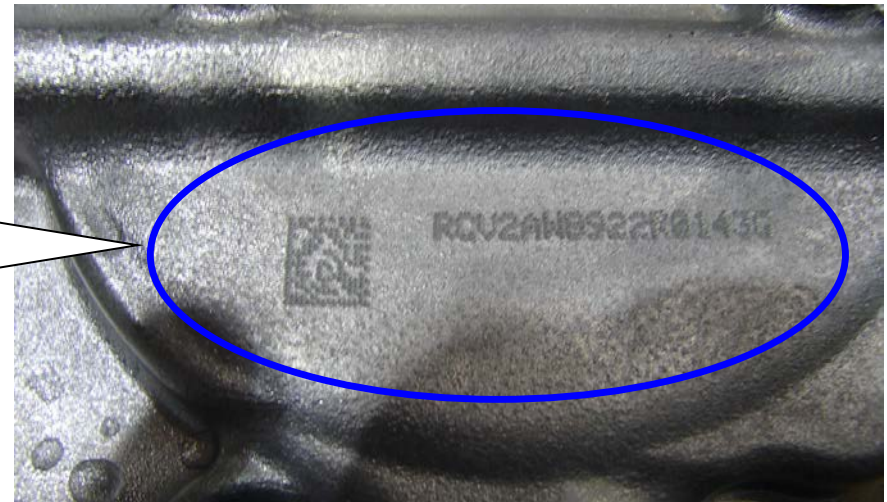
### **Visi-Trak**

Generates 2D code serial # while storing process data with identical file name

### **Telesis**

4 pin marking head writes 2D code data sent from Visi-Trak in under 8 Sec.

### **Keyence**

2D code reader sends serial # to computer which also stores leak test results

In order to make these detailed engineering studies more efficient and timely we decided to implement a data tracking system using a 2D bar code applied in the casting cell.

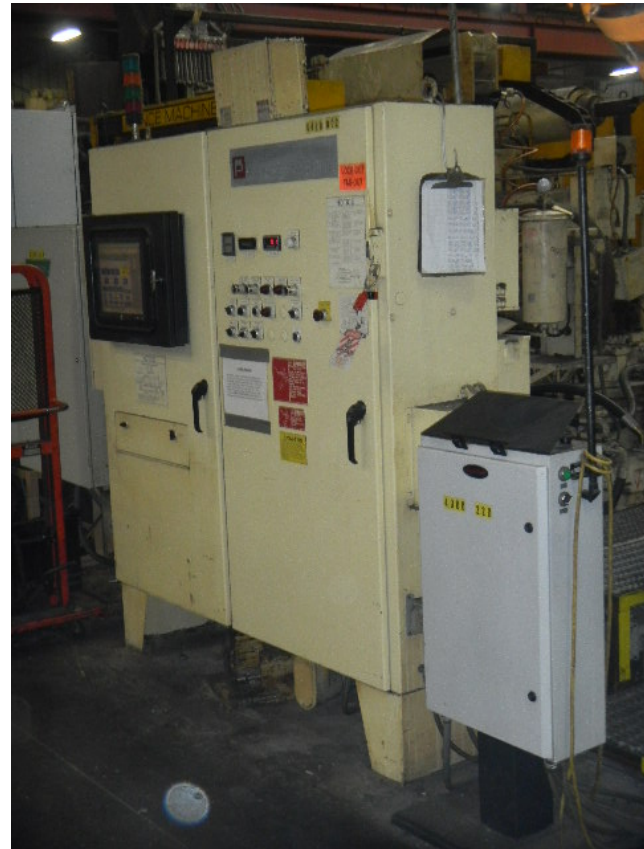
### A Sustainable Solution

- **2003** - PHB chose an affordable, well - supported system which provided high speed data collection
- They started with **8 Buhler machines** already equipped with OEM supplied monitors
- **Alarms** were placed on each machine.

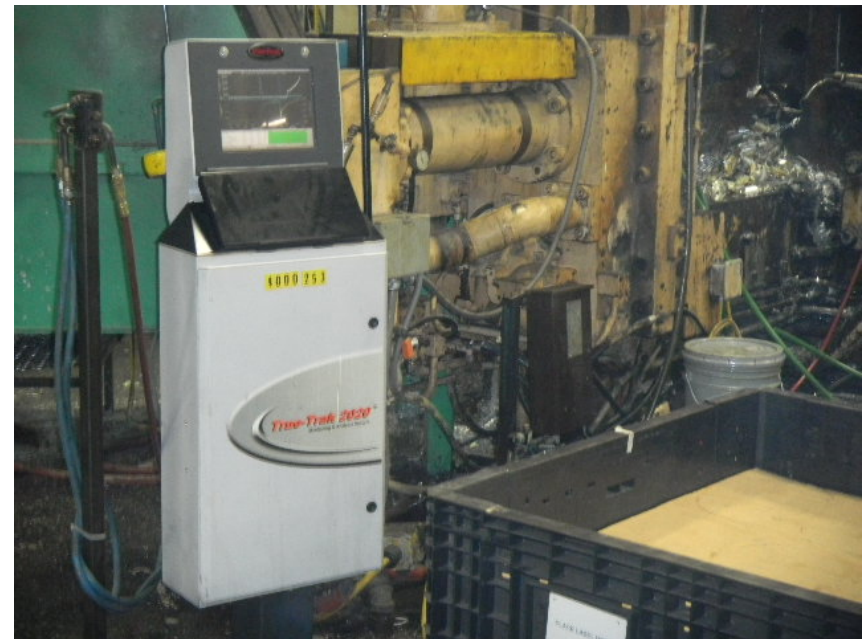
### Plant wide Expansion

- 26 machines had no OEM supplied monitors
- These were retrofitted with fully integrated monitoring system with local display of process data

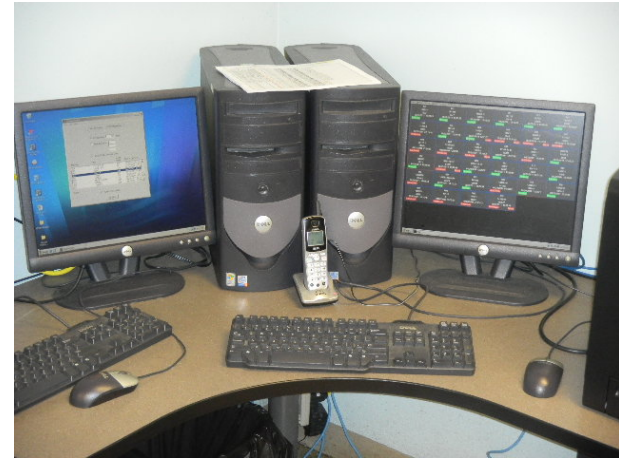
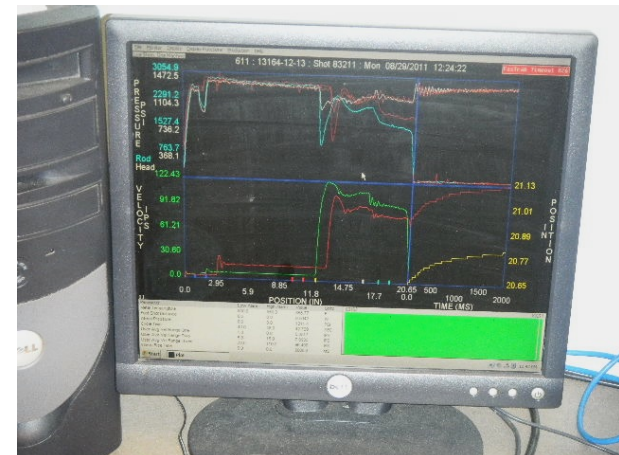
### Networked Solution

- The systems were connected via an Ethernet network
- Data collection computer on the shop floor
- Workstations computers in the process control office...
- Data Archiver for back-up and recall
- and to other work stations throughout the plant

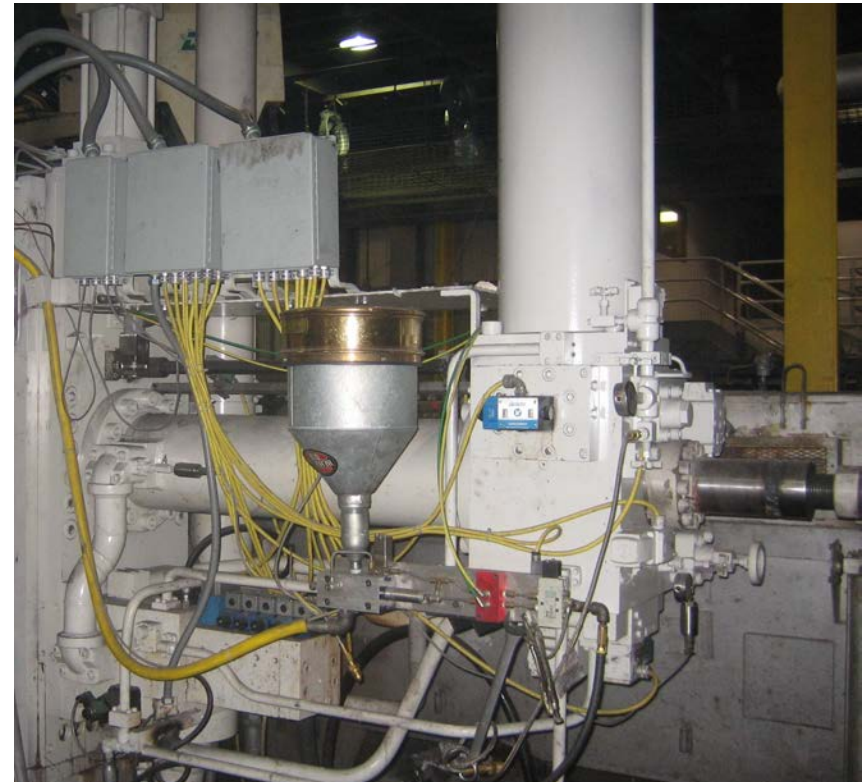
Prince 1600-ton with Binary II shot valve

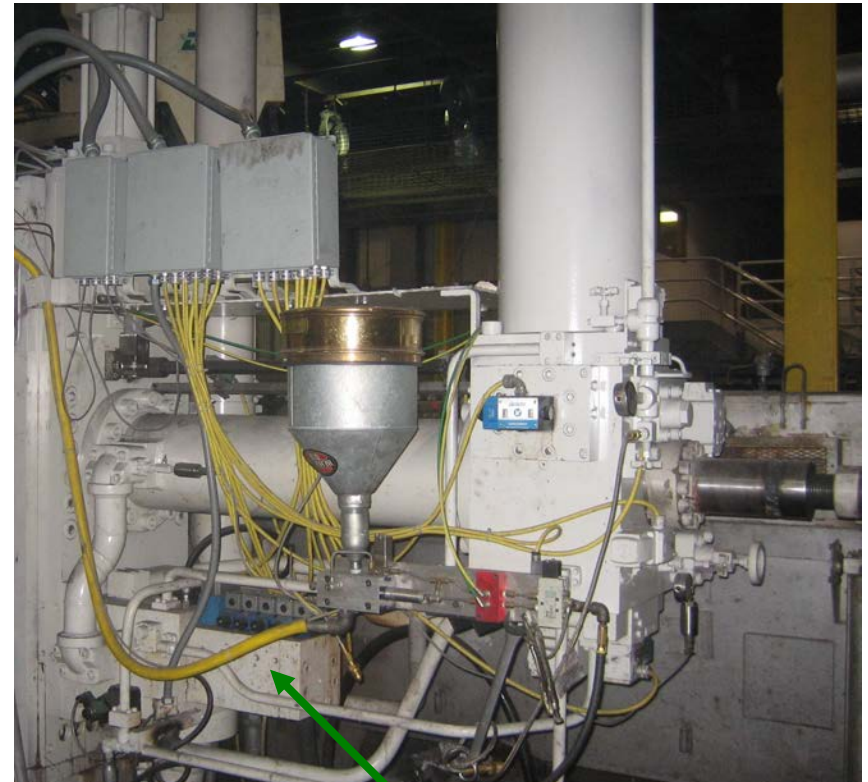
- 1600-ton Binary II three-speed shot system.
- Upgraded with ramping capability for the slow and intermediate velocities.
- No low impact system.

**Binary II shot valve**

- **Binary II shot valve developed leakage issue**
  - Occasional cracked segment on the valve – changed the velocity profile and caused scrap.
- **Binary II shot valve segments not collapsing properly**
  - Caused inconsistent shot speeds in fast shot
  - Caused scrap castings from where poor fill resulted from increasing fill times.
  - Operators frequently adjusting the shot control settings trying to maintain filling velocity.
  - **Variation caused scrap rate climb and need to make a change!**

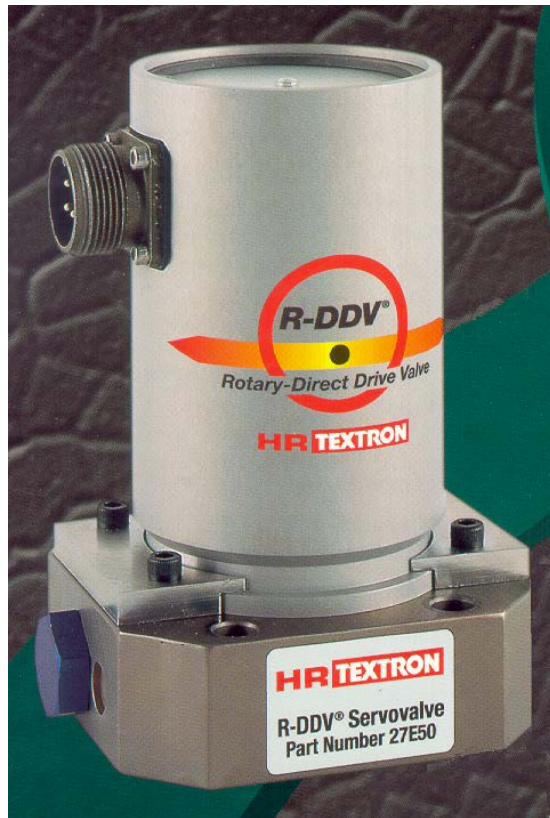
## HR Textron R-DDV Direct Drive

Has been successfully proven over many years in the rugged die casting environment

- Remove Binary II shot valve and manifold block
- Direct bolt-in replacement with:
  - Olmsted 80mm two-way, servo-piloted throttling valve slip-in cartridge format
  - Piloted by an H.R. Textron R-DDV servo pilot valve
  - PO check valve releases oil to retract the shot cylinder
  - Cartridge valve develops pressure to retract the shot cylinder
  - Cartridge filter ensures a clean oil supply

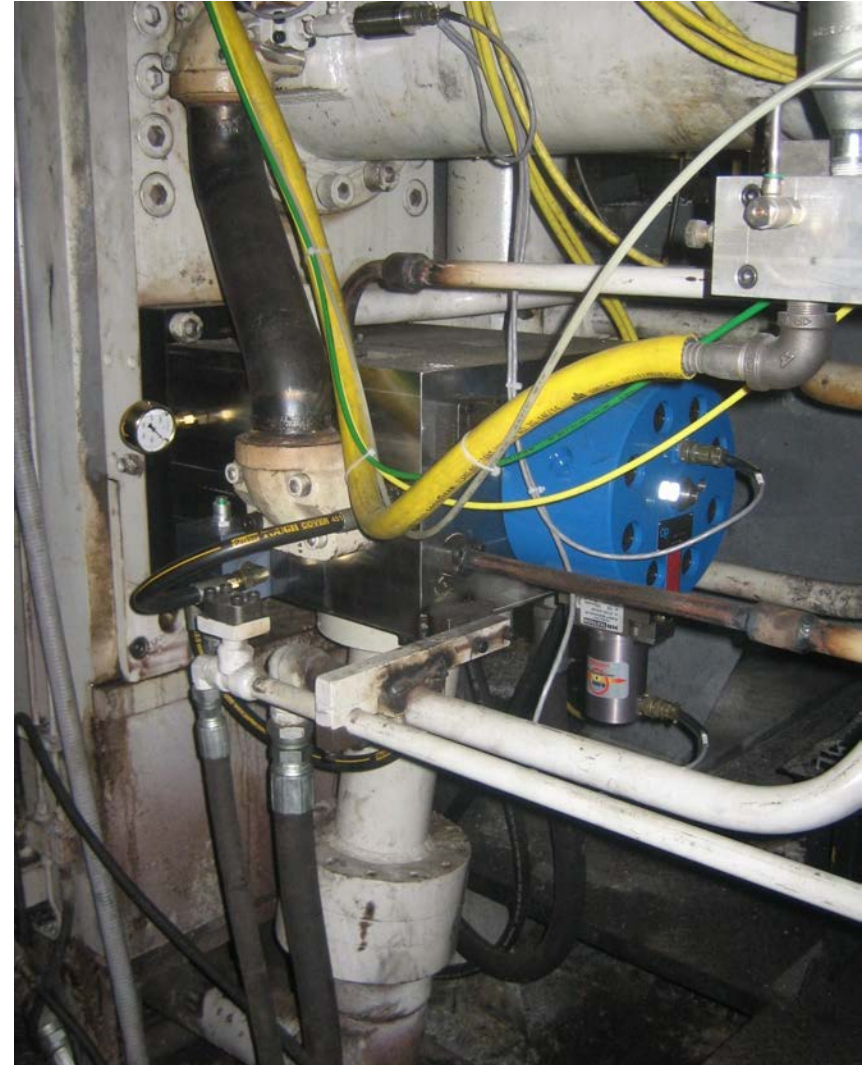
- Manifold bolted-in
- Original connections replaced with new fittings
- 3" high pressure pipe moved 3" to accommodate new block
- Rotary rack and pinion encoder replaced by a Visi-Trak Sensor in 1" tail rod.

**Total install < 3 days**

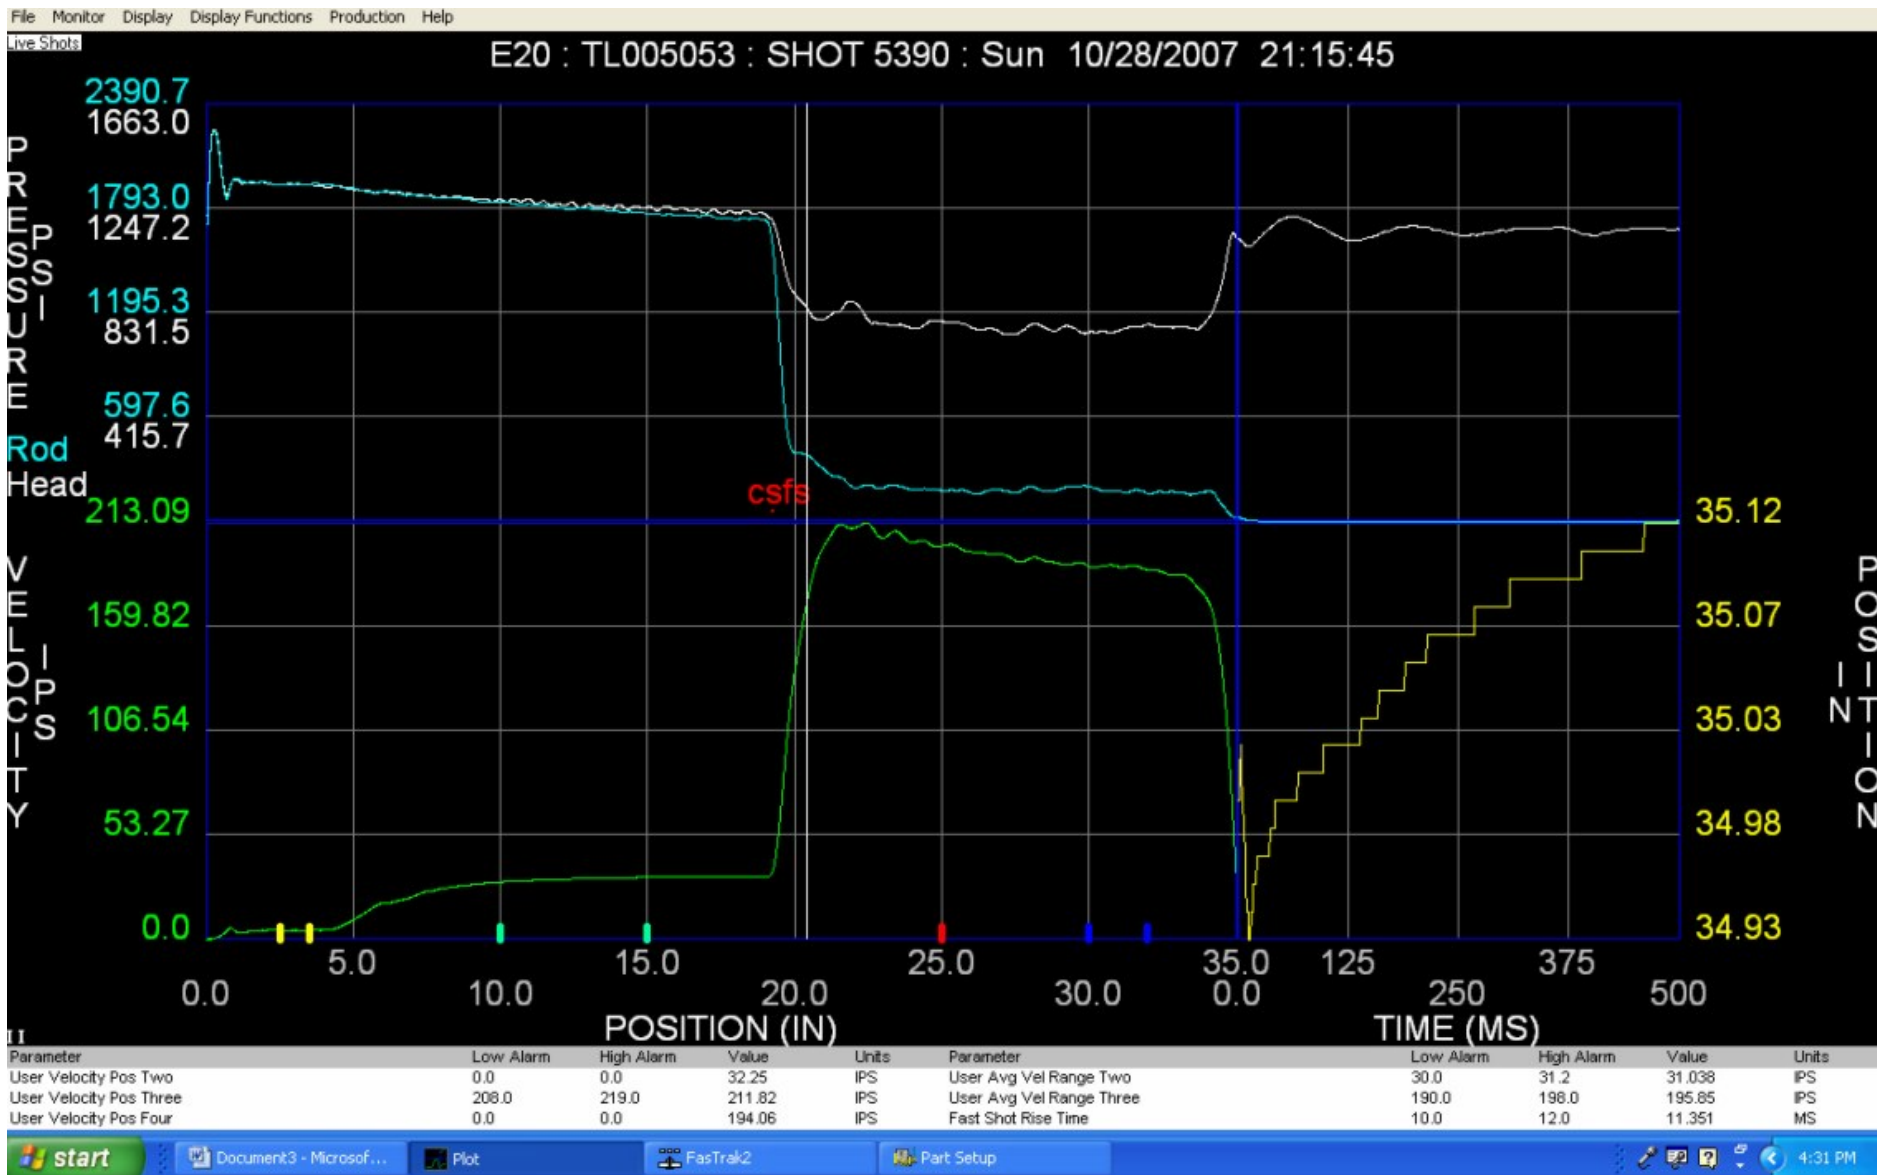
## Performance Results

**"The new valve increased our top speed by over 100" per second and has made it possible to continue creating cost-effective castings even after we outgrew the original capability of the machine."**

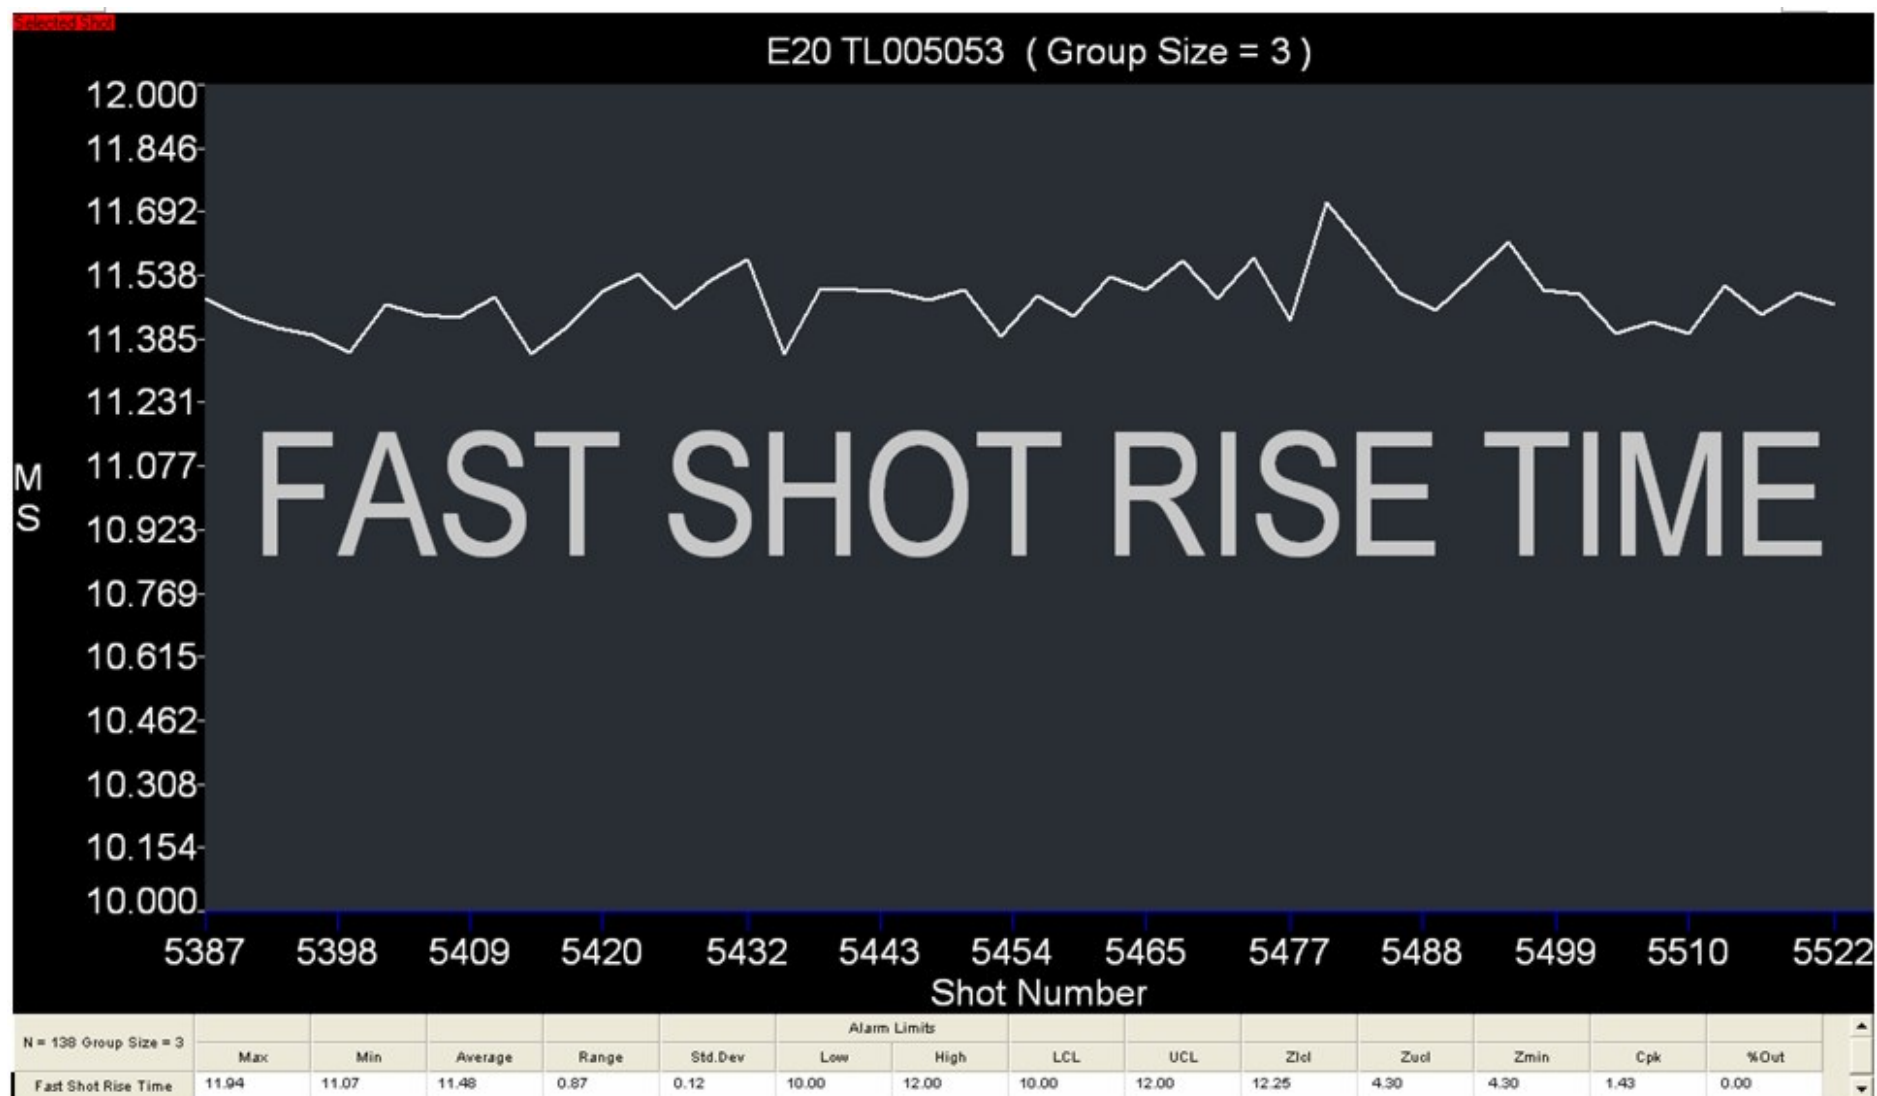
**X-Bar Chart – Repeatability from 25-30” of stroke**
